## **MARINE SAFETY ALERT**

Alert 07-09

### **SAILBOAT RIGGING DANGERS**

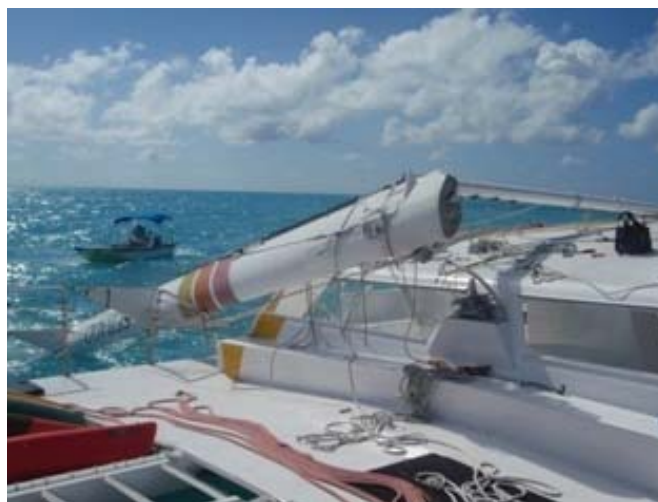
Recently in the Florida Keys, the standing rigging of a 60' inspected passenger carrying sailing catamaran failed, causing its rotating *wing spar* mast to collapse. Evidence suggests that the port shroud parted where it exits a swageless mechanical end fitting located on the upper mast at a common shrouds/stay connection. Although there were a number of passengers onboard at the time there were no resultant injuries. A six year review of Coast Guard casualty data shows 28 similar type casualties involving inspected sailing vessels. Of those 28, nine involved the failure of mast, spars and rigging components leading to dismastings; six of those involved sailing catamarans. Two separate catamaran dismasting resulted in two fatalities.

Common among the dismasting casualties was the failure of the mast's standing rigging. While this investigation is ongoing, initial forensic metallurgical analysis of the failed cable strands showed visual corrosion and evidence of fatigue failure. The shroud cable and swageless end fitting had been installed seven years prior.

The Coast Guard **strongly reminds** all commercial vessel owners/operators, especially those of passenger carrying sailing catamaran's of similar build, of their responsibility to maintain their vessels, associated equipment, systems and components in a satisfactory condition suitable for their employed service at all times. Owner and operators should not wait until regularly scheduled Coast Guard inspections to identify problems but should be ever vigilant and implement routine inspection, maintenance, and repair procedures in accordance with good marine practice and in alignment with applicable requirements. Owners and operators should consult the vessel manufacturer or other naval architecture, marine engineering services or qualified rigger regarding any concerns they might have regarding the regular flexing and working of their vessel's standing rigging

Inspection requirements for small passenger vessels are found in 46 CFR 175-185. Additionally, Coast Guard Sector Honolulu, by consensus with their local sail vessel industry, developed Inspection Note #13 that outlines an enhanced inspection regime for sailboat rigging, masts and associated components for their inspected small passenger sailing vessel fleet consisting almost entirely of catamarans. This information is useful to both marine inspection personnel and vessel owners/operators and is available by searching the web using the key words: "Sector Honolulu Inspection Note #13". Manufacturer published guidelines on mast and rigging system maintenance can be found in "Rigging Service Guidelines" <http://www.navtec.net/docs/RiggingService.pdf> published by Navtec Rigging Solutions. Practical standing rigging inspection information from a marine surveyor's perspective is available at <http://www.dixielandmarine.com/yachts/DLrigprob.html>.
